# Parallel Workshops: Design and Delivery – Operational solutions for creative regeneration

To understand the technical challenges facing 2 regeneration projects (Portumna Courthouse, Galway) and (Cultuurcampus, Rotterdam)

# PORTUMNA COURTHOUSE - 1847

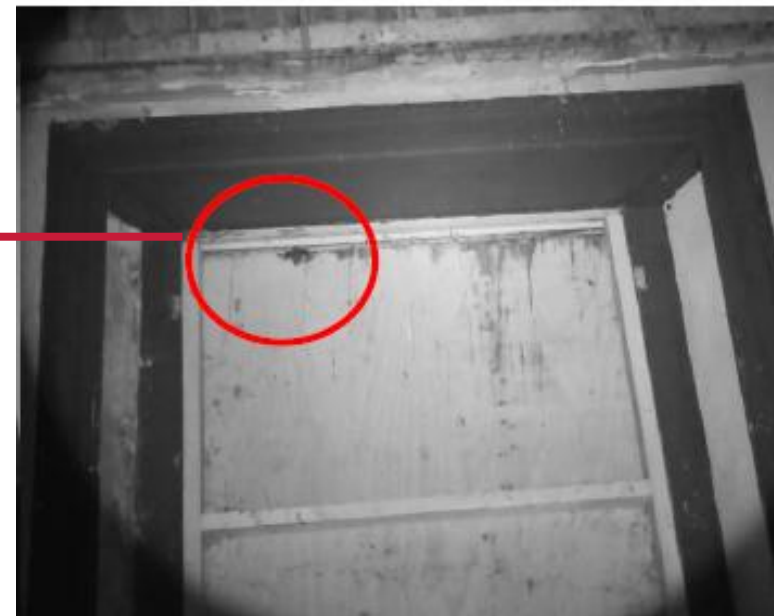
Soprano pipistrelle Bat Detected Exiting Building as Part of 2021 Ecology Survey

Bat activity was detected as part of Ecology survey at Part 8 planning permission stage.

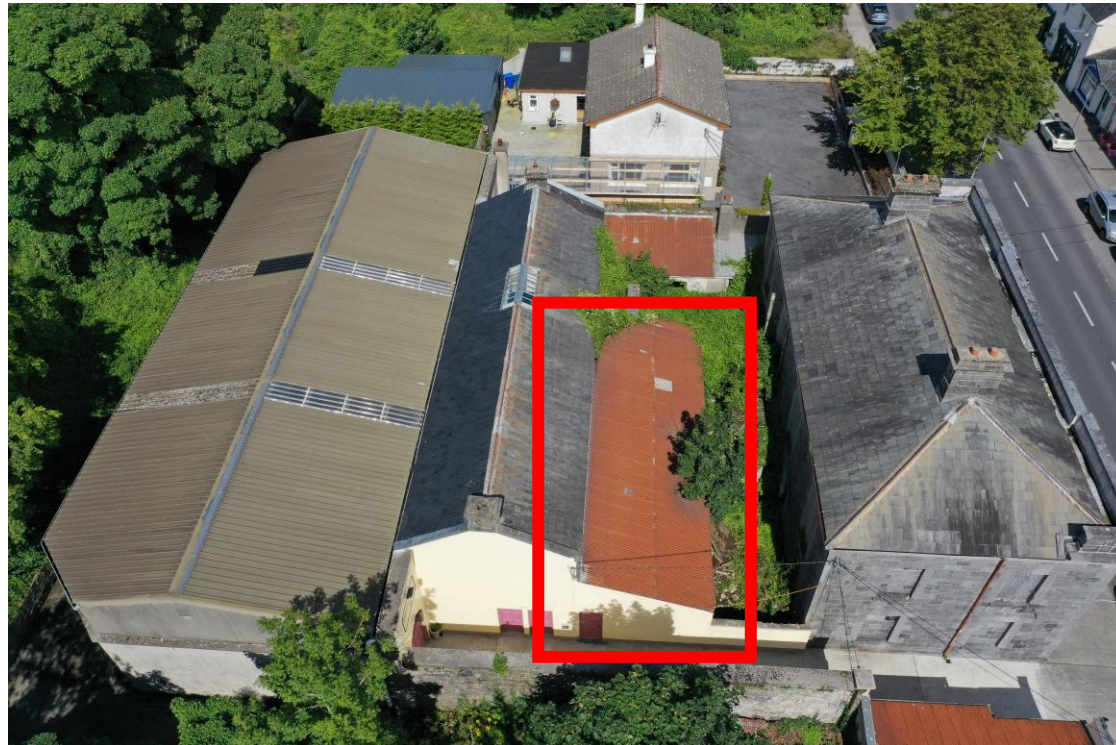
Demolition of Lean-to Extension on Adjacent Bridewell Unearthed Original Entrance Door & Windows

Discovery of Original Entrance to Bridewell during Demolition Works.

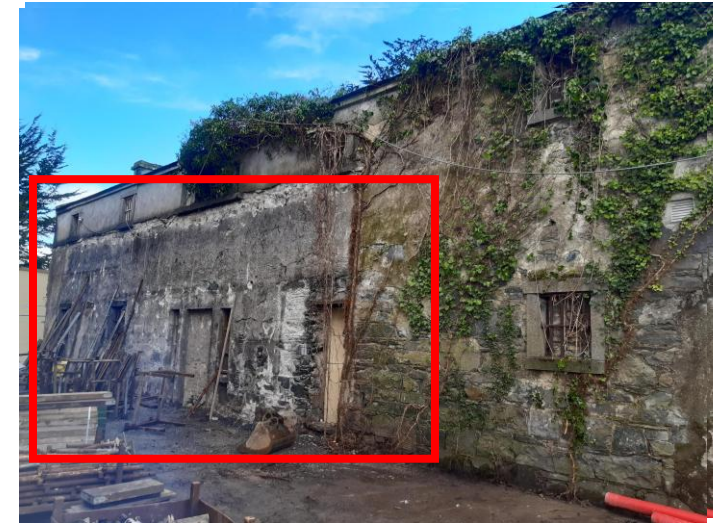
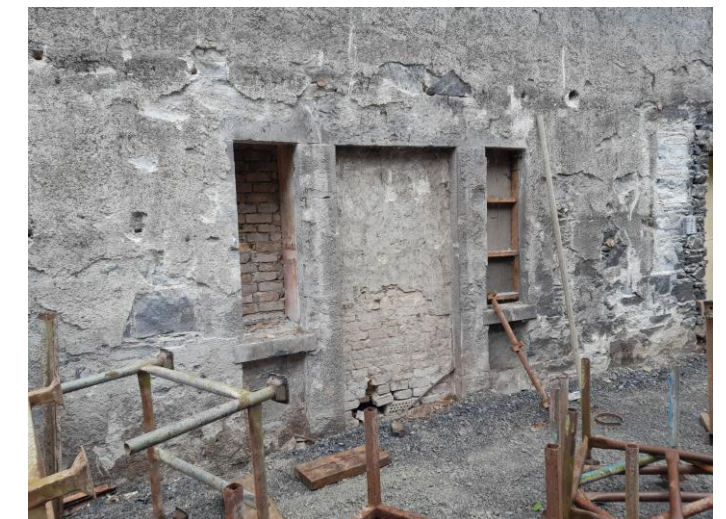
Close-Up of Original Bridewell Entrance Door & Windows

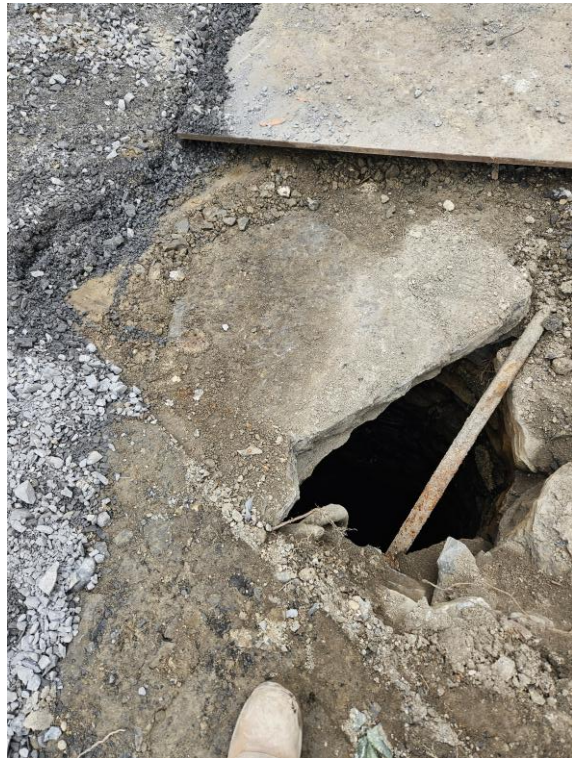
Well on Discovery – Covered with Flag Stone

Discovery of Well in Courtyard During Demolition Works – Not Recorded on Historic OS Maps!

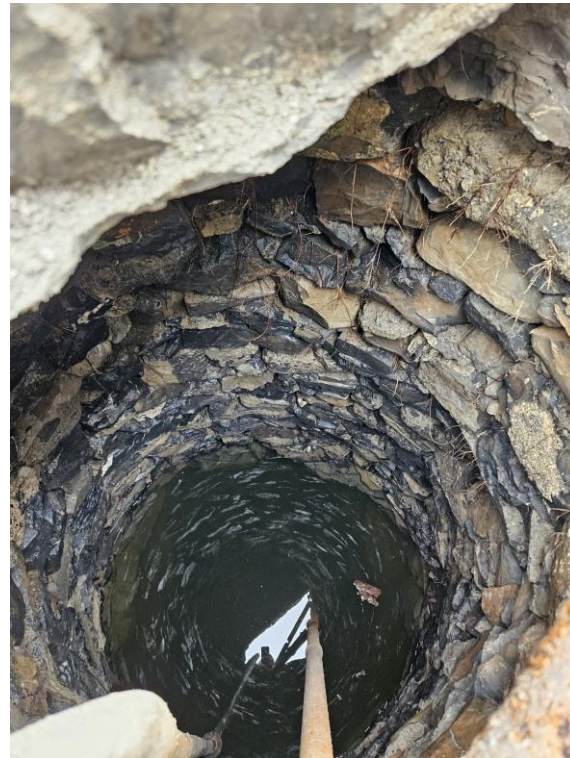
Early Photo of Exposed Well

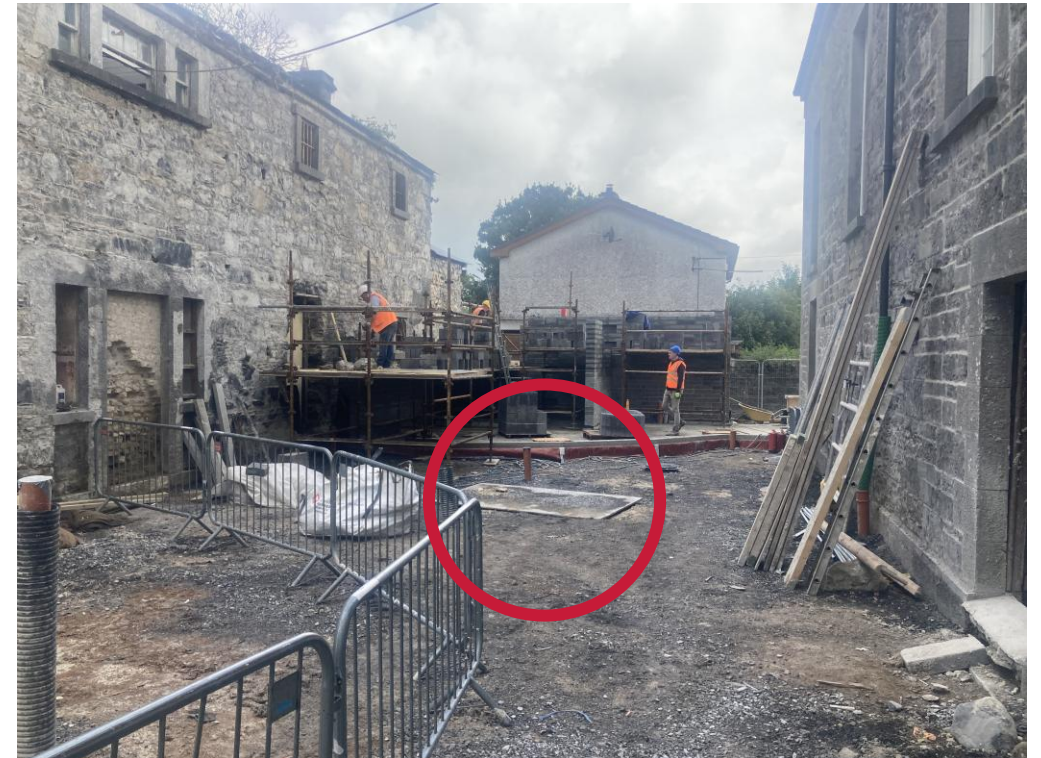
Well Located in Centre of Courtyard

Challenge	Key Solution
Clash with proposed services & external furniture.	Early decision making enabled suitable redesign where necessary. The well surround was utilised as a piece of furniture.
Protection of groundwater.	Glass lid offering protection from possible contaminants
Risk of flooding.	Land drain beneath paving provided protection against rising water levels.

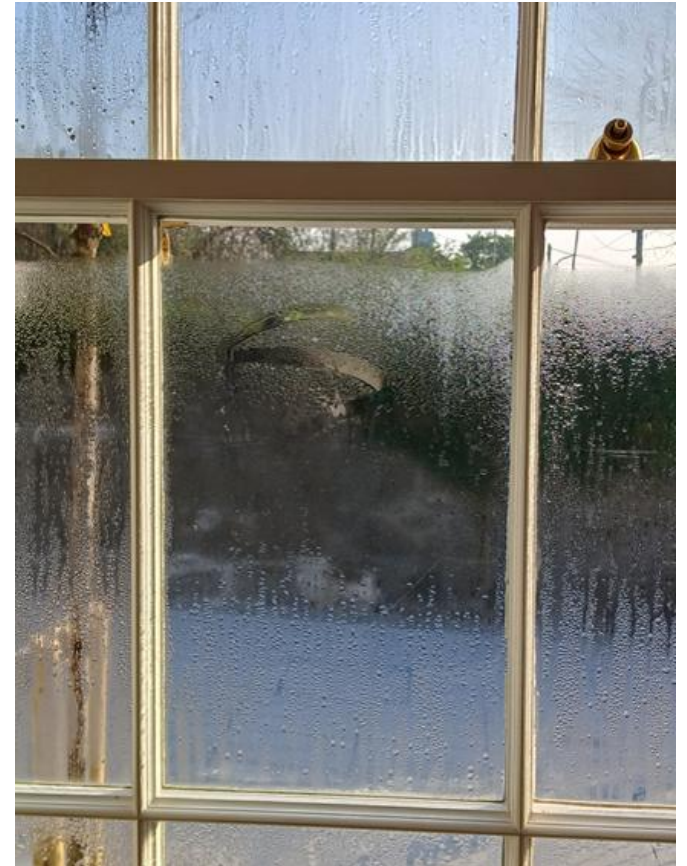
Condensation present on single glazed windows

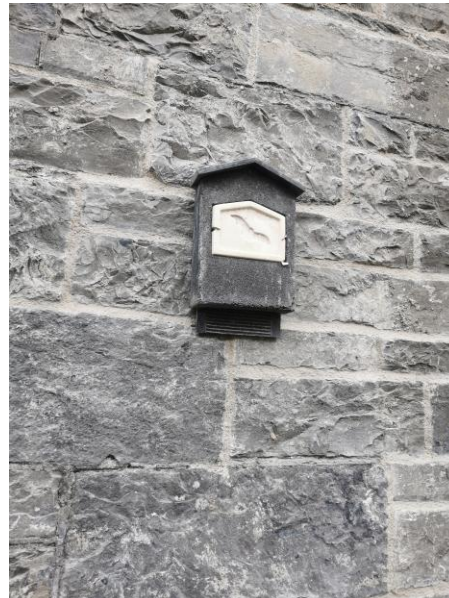
Temporary Bat Box

- Immediately procuring the services of a **local** Ecologist ensured that site visits and sign off could be undertaken relatively quickly.
- Early engagement with contractor allowed for a reworking of the programme to prioritise stripping of roof and demolition works.

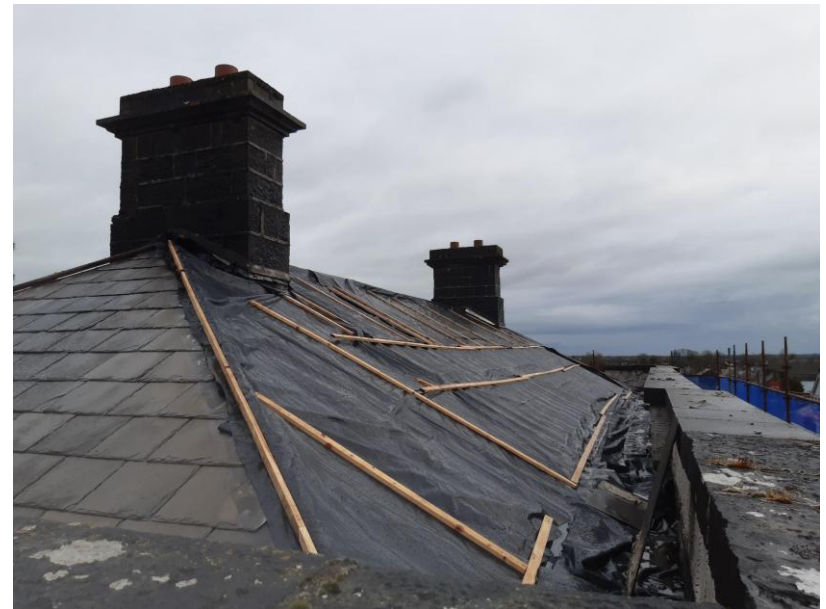
Temporary Covering of Exposed Roof

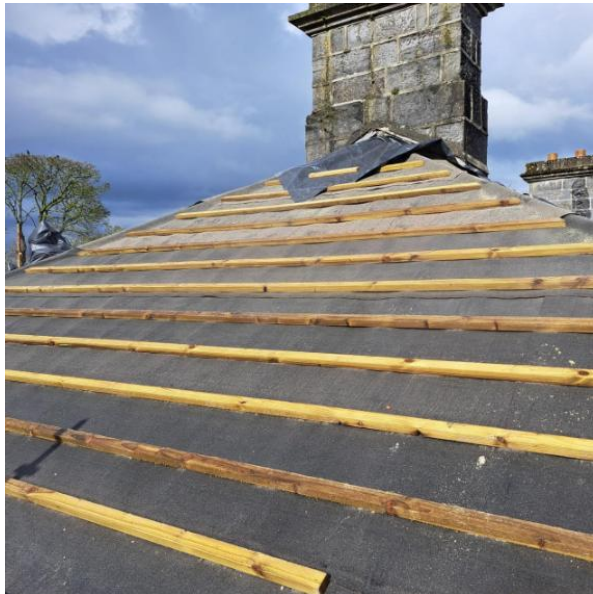
Non-Woven Bituminous Roofing Felt

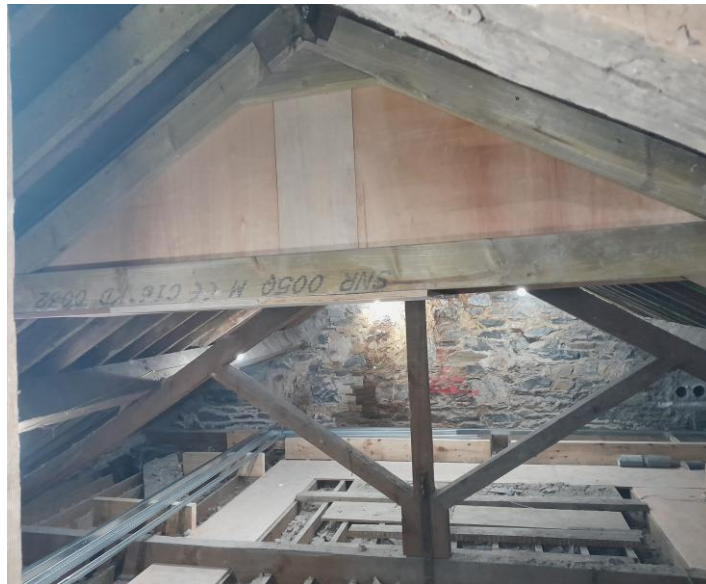
Accommodating Bat Roost in Attic Space

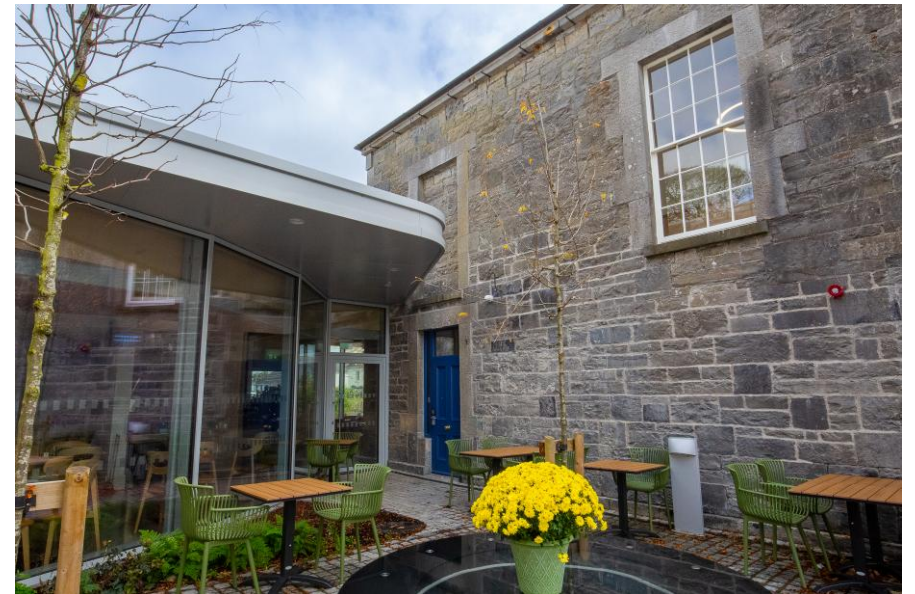
- Mitigation proposals were put forward early in the project to ensure all trades were informed.
- Continuous engagement with local NPWS ranger throughout the project to agree an external lighting strategy – all light fittings downward facing, max. 2.1m high and max. 2700k.

Downward Trajectory of External Lighting

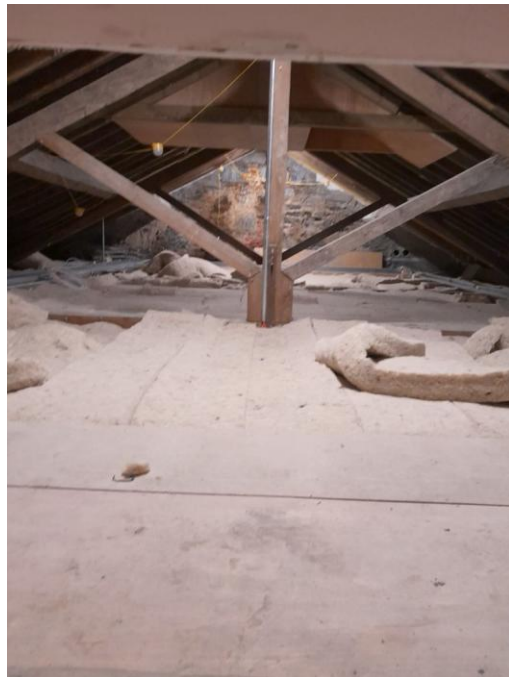
Challenge	Key Solution
Improve thermal efficiency of building without compromising historic fabric.	Use of natural products which allow the building to breath.

Sheeps Wool Attic Insulation

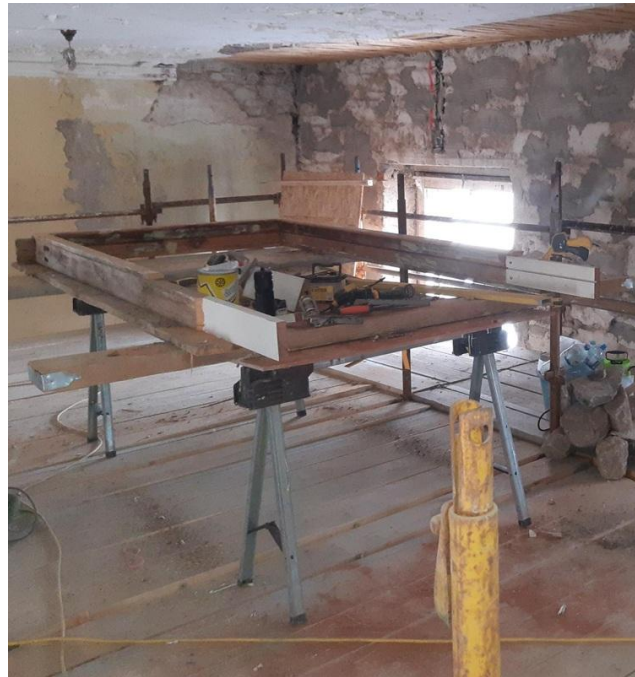
Window Repairs and Insulating Render

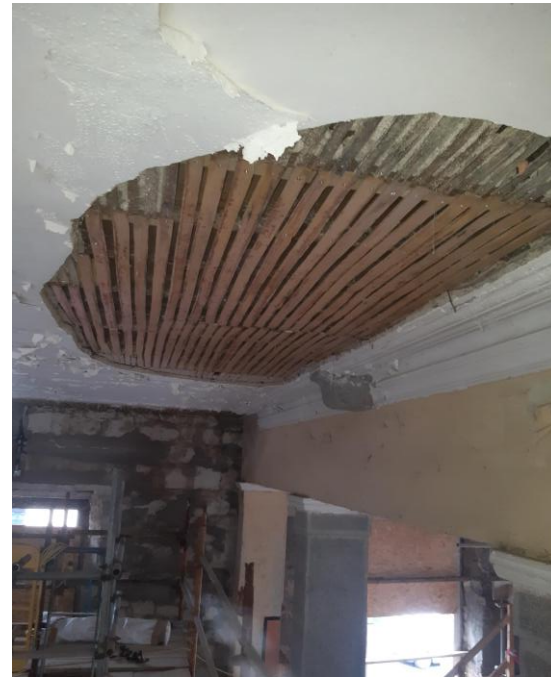
Decision to retain / repair existing lath and plaster ceilings

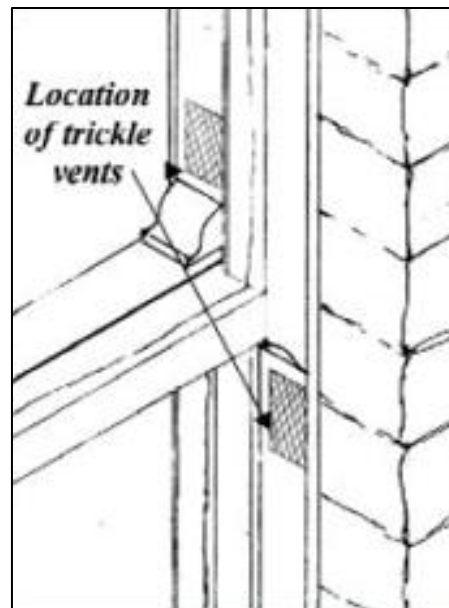
Purpose-made vents can be fitted in new windows, but it could compromise the strength of the timber to cut one into an existing sash or casement. If sash windows fit so well that ventilation is insufficient, it may be possible to fit a thin block to the top of the frame stile to prevent full closing of the upper sash. Sashes altered like this should be secured by locks at the sides instead of the meeting rails. This allows a permanent trickle of air at the top and meeting rail, which is usually over the head level of the occupants. If secondary glazing is used, the original window must be ventilated to the exterior. Permanent trickle vents can be fitted into box frames by a careful joiner. Cut two small oblong holes in the frame stiles near each other: one to take air directly from the outside into the weight box and the other to draw it from there into the room. Fit a grill or mesh over the holes, making sure that the sashes slide smoothly over them.

Challenge	Key Solution
1. Ventilation	Lessons Learned – Possible over reliance on natural ventilation strategy.  Work in progress – Currently investigating options to increase background ventilation.

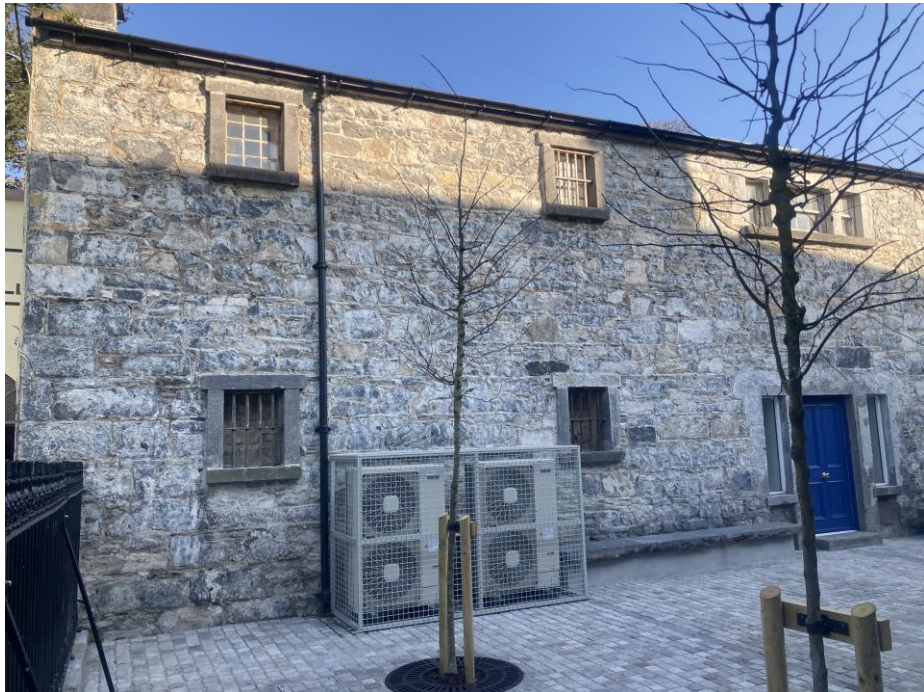
Challenge	Key Solution
1. Sustainable solutions	Air sourced heat pump

Air Sourced Heat Pump
